BOEING 737-8200 MAX ELT System Installation

Task Objectives

Airframe Designs was engaged by EIRTECH (EASA Part21J DOA) to provide design support and stress analysis for the installation of an Emergency Locator Transmitter (ELT) system into BOEING 737-8200 (MAX) aircraft.

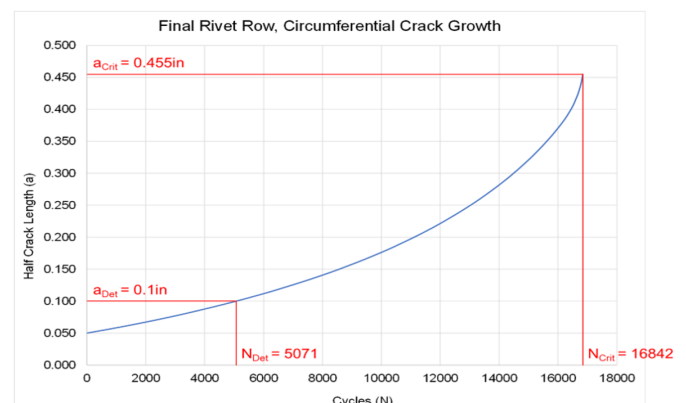
The damage tolerance evaluation for the antenna installation focussed on the skin penetration and riveted joints connecting the reinforcing doubler to the surrounding skin.

A traditional crack growth analysis was undertaken to determine threshold and repeat inspection intervals for the feed-through and final fastener rows in both the longitudinal and circumferential directions of the fuselage.
